Stormwater Industrial Routine Facility Inspection Report

General Information			
Facility Name	Caldwell Industrial Airport		
NPDES Tracking No.	IDR 050007		
Date of Inspection	March 25, 2021	Start/End Time	10:00 AM / 3:00 PM
Inspector's Name(s)	Ashley Newbry, Emily Johnson		
Inspector's Title(s)	Assistant City Engineer, Environmental Engineer (City of Caldwell Stormwater Program)		
Inspector's Contact Information	anewbry@cityofcaldwell.org, ejohnson@cityofcaldwell.org		
Inspector's Qualifications	SWPPP Primary and Secondary Contacts		
Weather Information			
Weather at time of this inspection?			
<input type="checkbox"/> Clear <input checked="" type="checkbox"/> Cloudy <input checked="" type="checkbox"/> Rain <input type="checkbox"/> Sleet <input type="checkbox"/> Fog <input type="checkbox"/> Snow <input type="checkbox"/> High Winds <input type="checkbox"/> Other: _____ Temperature: _____			
Have any previously unidentified discharges of pollutants occurred since the last inspection? <input type="checkbox"/> Yes <input checked="" type="checkbox"/> No If yes, describe:

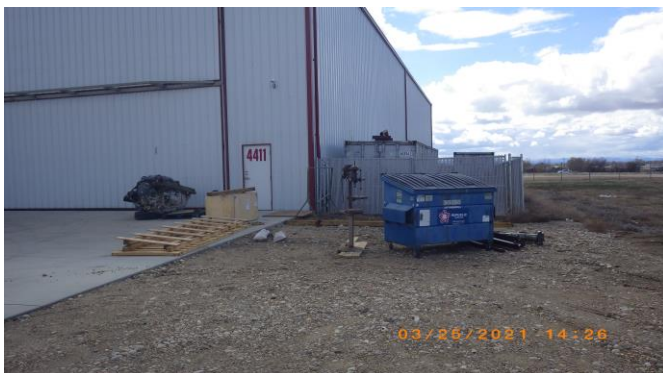
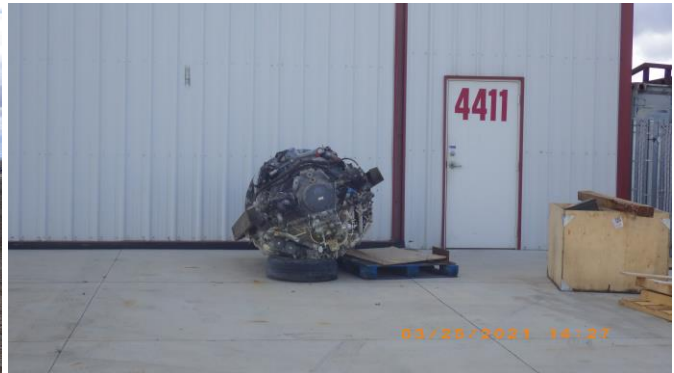
Vintage Airframes, LLC (4411 Aviation Way)

Aircraft engine is sitting outside the hangar, without any containment in place to collect residual fluids or stormwater runoff from the component. Industrial maintenance components, such as the engine, should be stored inside the hangar or with properly installed containment to prevent contamination of stormwater runoff.

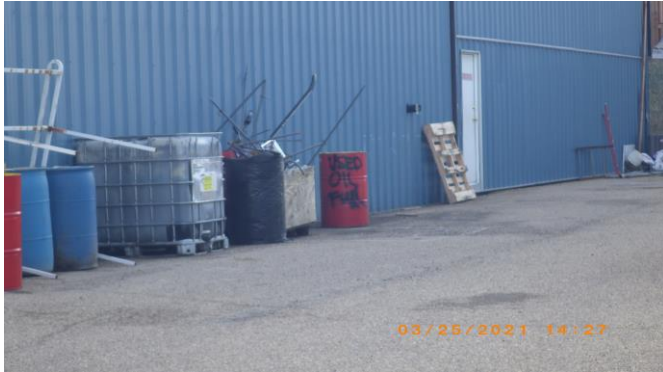
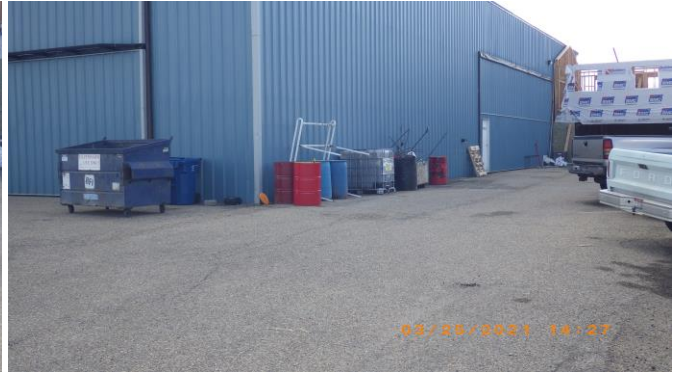
Silverhawk Aviation Hangar (4505 Aviation Way)

Chemical drums and containers are being stored outdoors without secondary containment. One of the containers observed during the inspection is painted with the words “Used Oil Full”. All chemical drums and containers must be stored indoors. If a variance has been granted by the Airport Manager to store these containers outdoors, secondary containment is required. The onsite dumpster lid is missing, should be replaced.

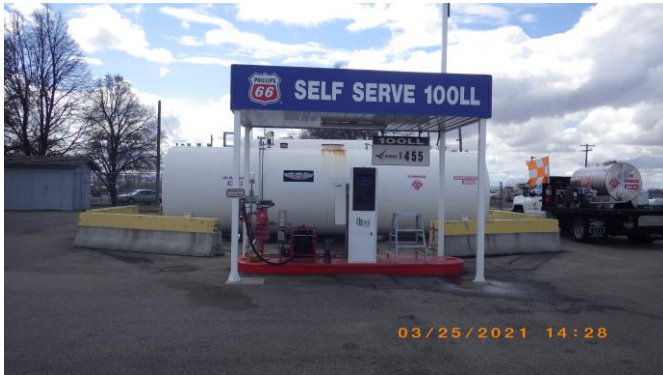
Silverhawk Site Stationary Self-Serve Refueling Station

Spill kit was not observed at or near the pump. Sites which are not attended 24 hours must display signage and provide access to the spill kit at all times. If the site does not have a spill kit, they need to obtain one. If the spill kit is not in immediate view of the pump, provide signage.

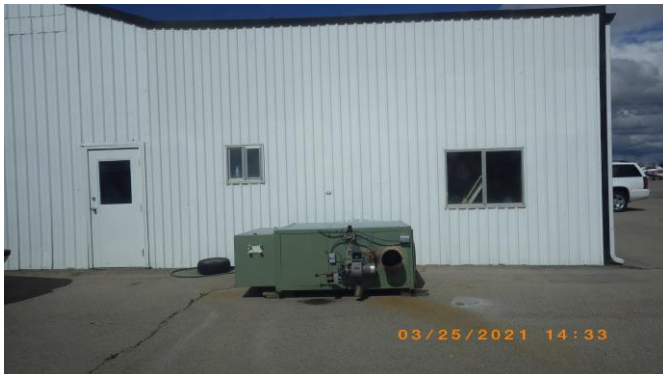
Aero Builders Hangar (4611 Aviation Way)

Piece of equipment (possibly a heating unit) is being stored outside the hangar. It should be stored inside the hangar; if variance has been granted to store outside the hangar, containment should be provided to prevent the equipment from coming in contact with stormwater. Staining on the pavement indicates potential maintenance/industrial activities have been occurring outside the hangar, all such activities should be conducted inside.

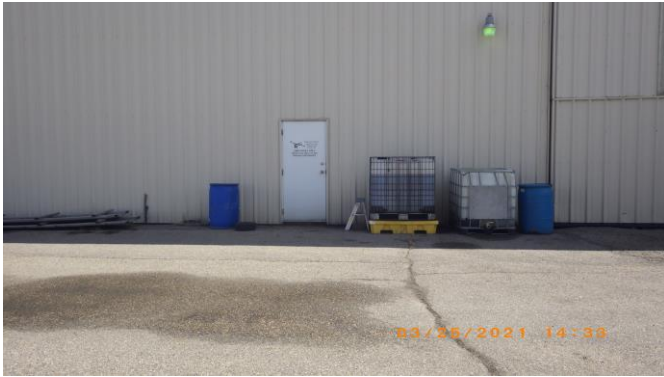
Performance Air Inc. (4919 Aviation Way)

The drums and containers being stored outdoors need secondary containment, or to be stored indoors. The container just to the right of the door (visibly contains a fluid) is an excellent example of secondary containment!

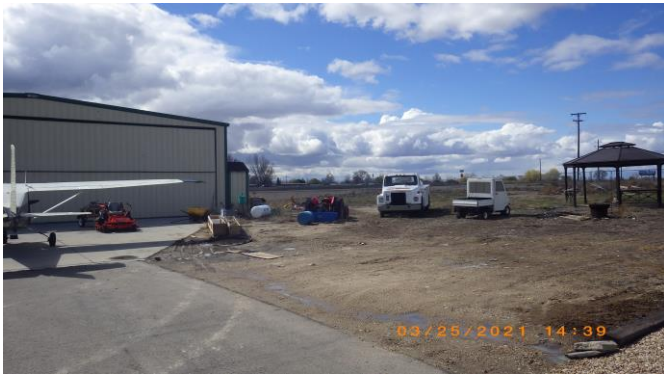
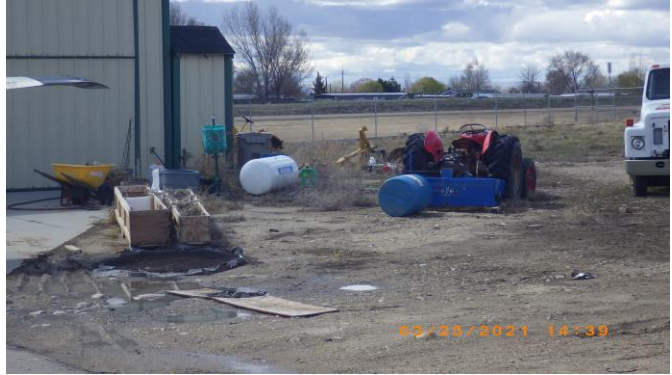
Skydown Skydiving Hangar and Fuel Tanker

Mobile refueling operation must carry a spill kit on the tanker at all times. Evidence of maintenance and chemical storage outside of the hangar. Maintenance must be conducted in the hangar where spills will not be exposed to stormwater. If a variance has been granted by the Airport Manager allowing chemical drums and containers to be stored outside, secondary containment is required. Should consider garbage service (i.e. a covered dumpster) for the site.

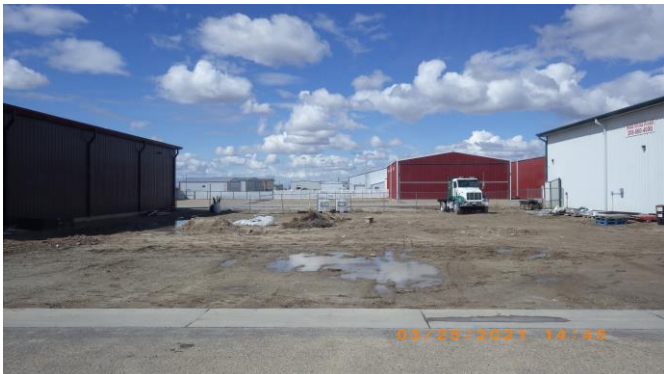
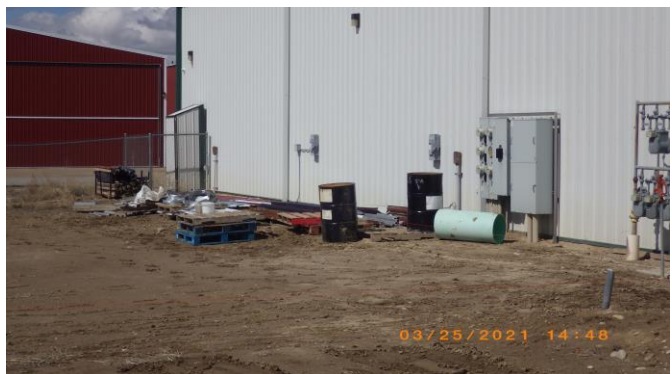
Solid Rock LLC Construction Area (between 507 and 519 Dishman Place)

All chemical drums and containers must be stored under covering and/or with secondary containment measures in place. Garbage service is recommended to address the trash accumulated onsite.

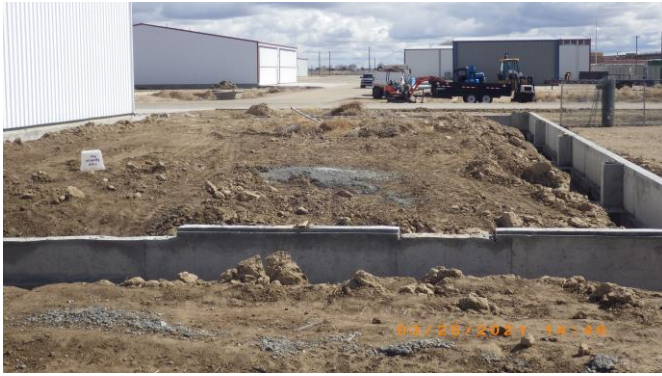
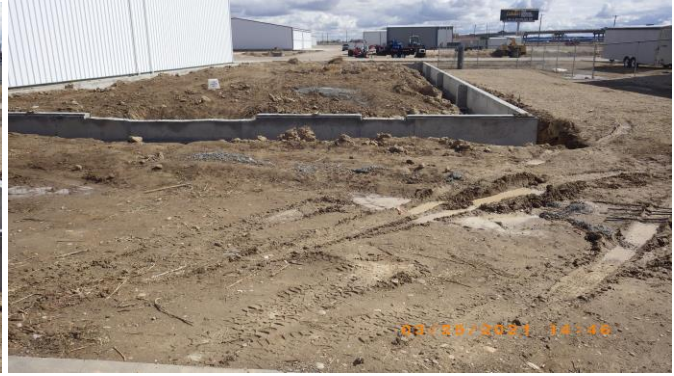
Construction Area (between 510 and 518 Dishman Place)

Need to install a concrete washout area, observed areas where concrete was washed out directly onto the ground.

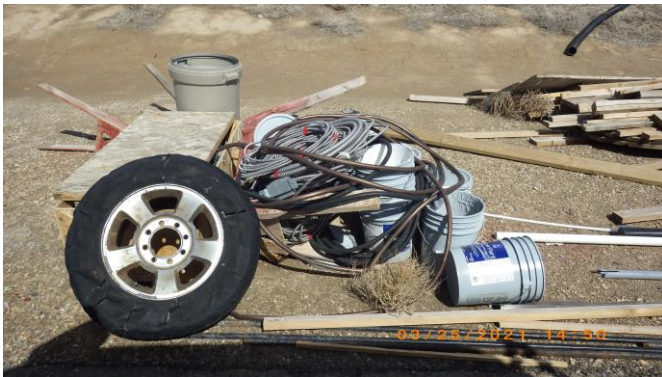
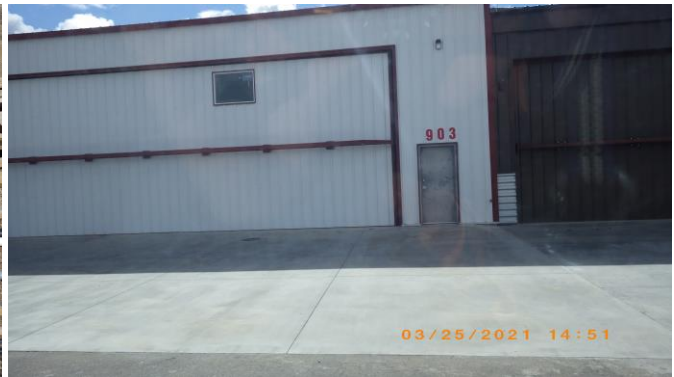
Hangar 903

Mostly empty paint containers, among other trash, have been placed in the grass/dirt across the taxiway from the hangar. These materials should be cleaned up and properly disposed of.

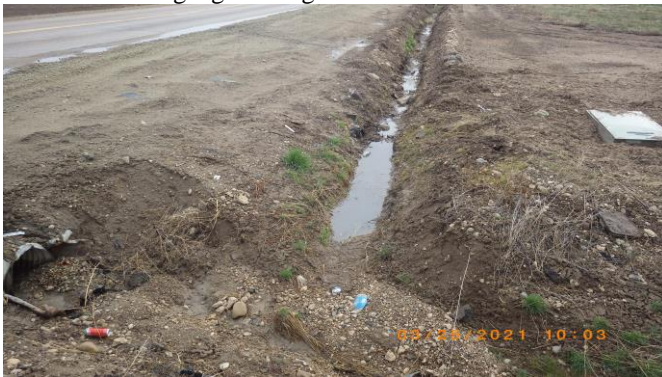
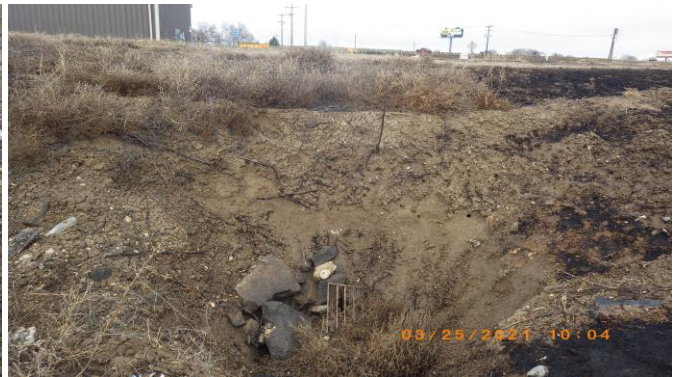
Drainage channel along Linden Avenue (left) and bank along Aviation Way (right), near the Linden-Aviation intersection, are both showing signs of significant erosion. Both of these areas should be stabilized.

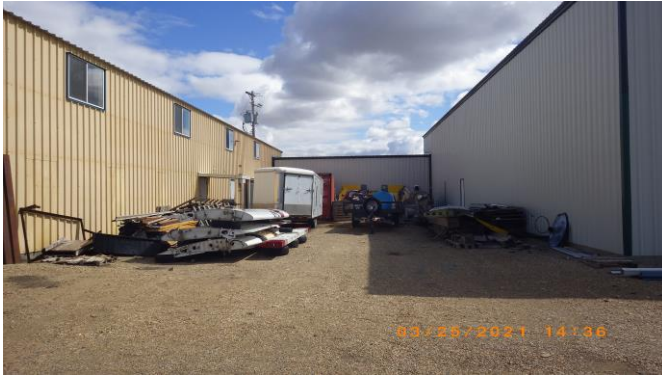
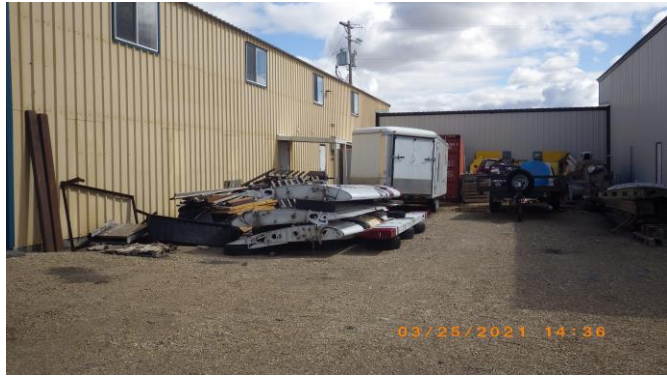
Flight Doctor West (515 Taildragger Place)

This tenant is storing a considerable amount of materials outside, in the space between their hangar and another tenant’s hangar. At this time, there did not appear to be maintenance or chemical storage in this area, however this area should be monitored to ensure no stormwater pollutants are being stored outside the hangar.

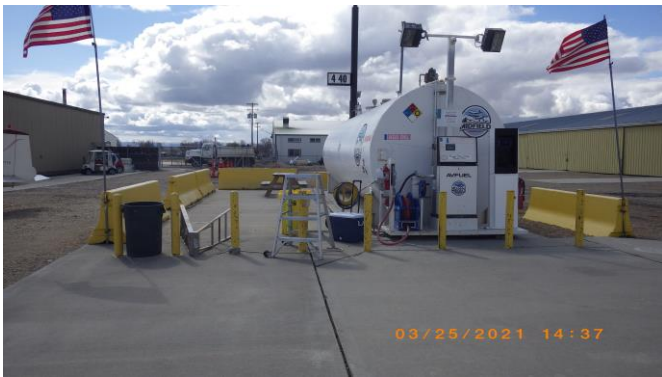
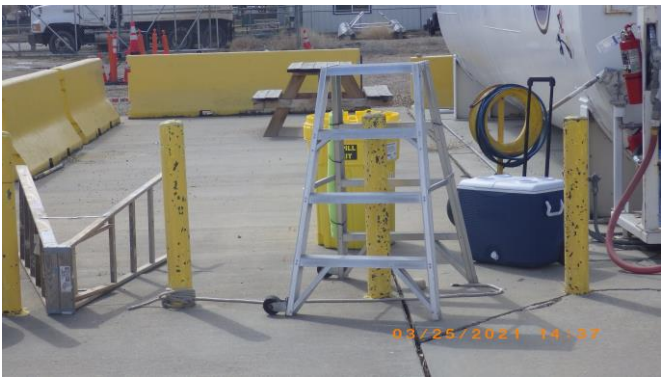
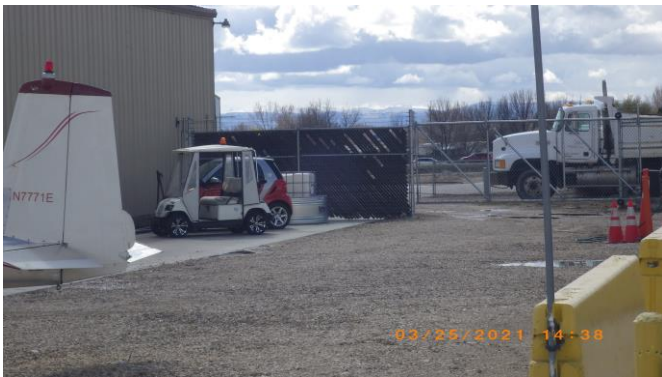
Midfield Aviation Stationary Self-Serve Refueling Station

Spill kit is onsite and easy to find, great job! Excellent secondary containment as well.
