Stormwater Industrial Routine Facility Inspection Report

General Information			
Facility Name	Caldwell Industrial Airport		
NPDES Tracking No.	IDR 050007		
Date of Inspection	September 20, 2021	Start/End Time	9:00 AM / 11:30 AM
Inspector's Name(s)	Emily Johnson		
Inspector's Title(s)	Environmental Engineer (City of Caldwell Stormwater Program)		
Inspector's Contact Information	ejohnson@cityofcaldwell.org		
Inspector's Qualifications	SWPPP Primary Contact		
Weather Information			
Weather at time of this inspection?			
<input checked="" type="checkbox"/> Clear <input type="checkbox"/> Cloudy <input type="checkbox"/> Rain <input type="checkbox"/> Sleet <input type="checkbox"/> Fog <input type="checkbox"/> Snow <input type="checkbox"/> High Winds <input type="checkbox"/> Other: Temperature: 64°F			
Have any previously unidentified discharges of pollutants occurred since the last inspection? <input type="checkbox"/> Yes <input checked="" type="checkbox"/> No If yes, describe:

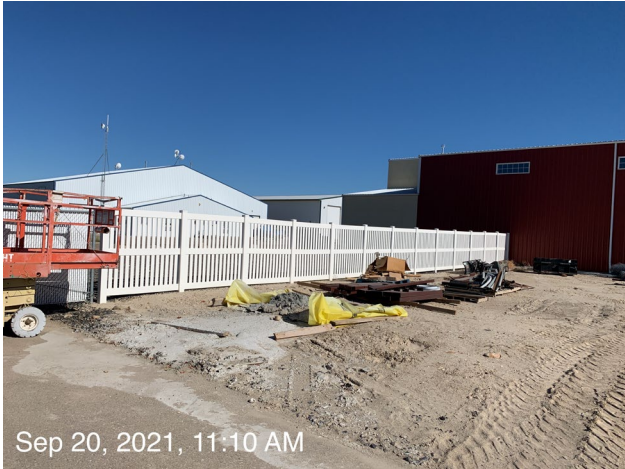
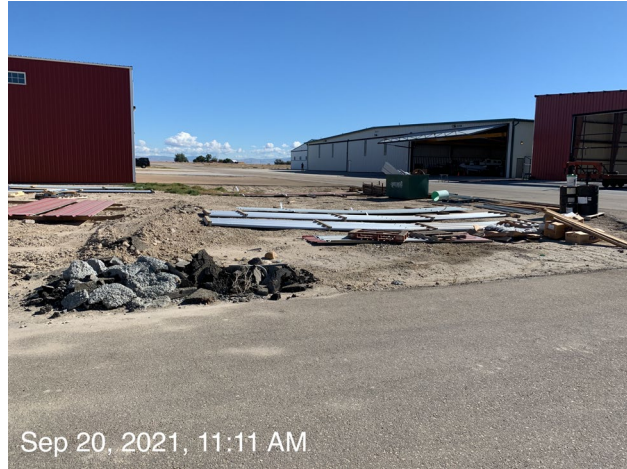
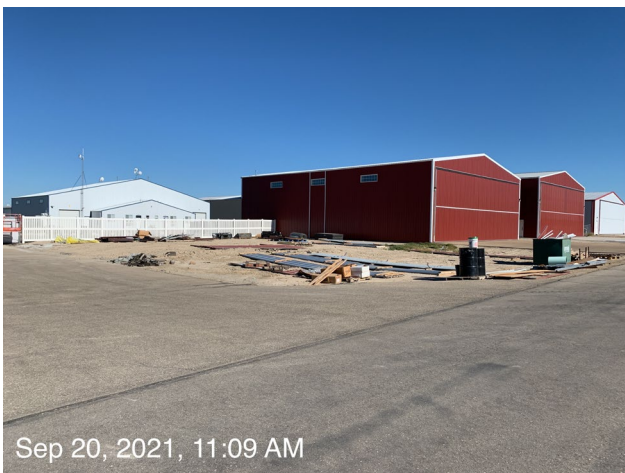
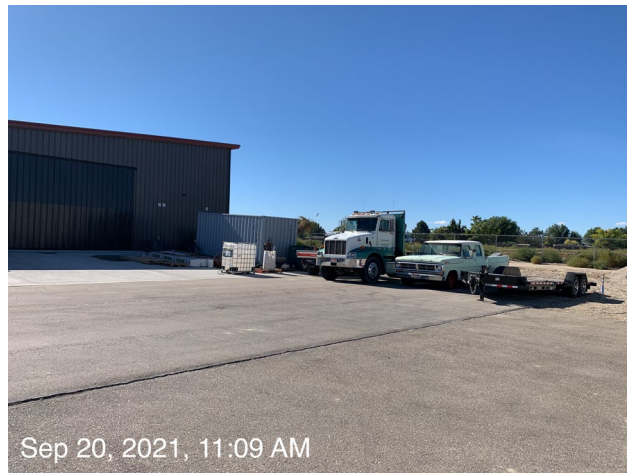
Construction Area (between 504 and 516 Dauntless Place)

Concrete is being washed out directly onto the ground and into a damaged concrete washout that is not effectively containing the material; concrete can **only** be washed out into a functioning designated concrete washout area. Any concrete washed on onto the ground must be cleaned up immediately. Unidentified drums and containers are being stored outside without any secondary containment; these materials **must** be stored inside, under cover, or with secondary containment to prevent contamination of stormwater runoff. The dumpster must have a lid or functional cover, and must be covered. No materials that could pollute stormwater runoff can be stored outside. To remediate non-compliance status:

- Install and maintain a concrete washout
- Clean up concrete that has been poured/washed out directly onto the ground
- Store drums and containers inside, under cover, or with sufficient secondary containment
- Obtain and use a lid (or other functional cover) for the dumpster
- Store any potential pollutants inside, under cover, or with secondary containment

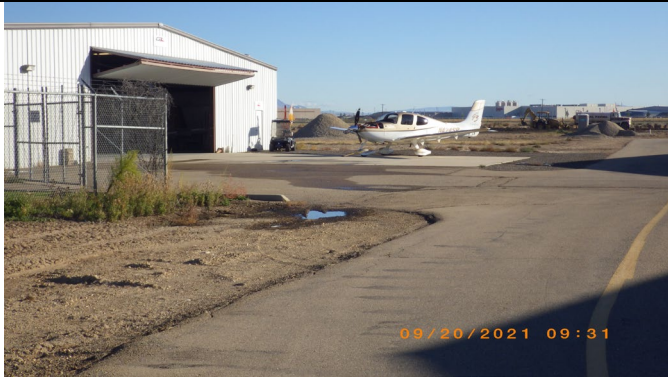
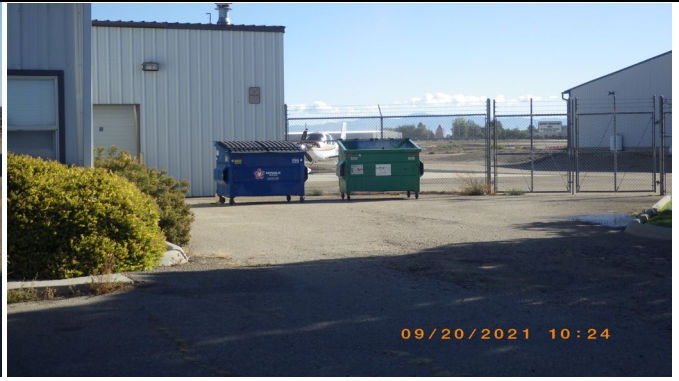
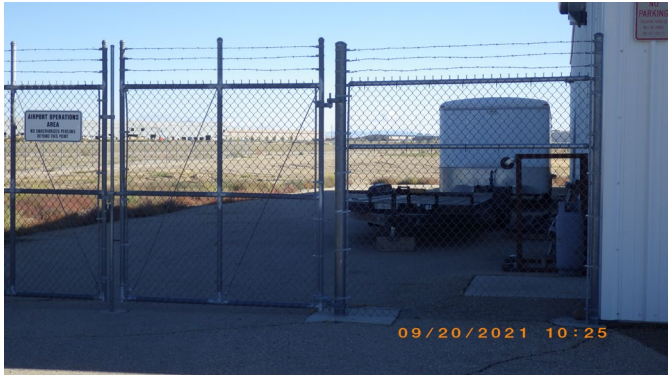
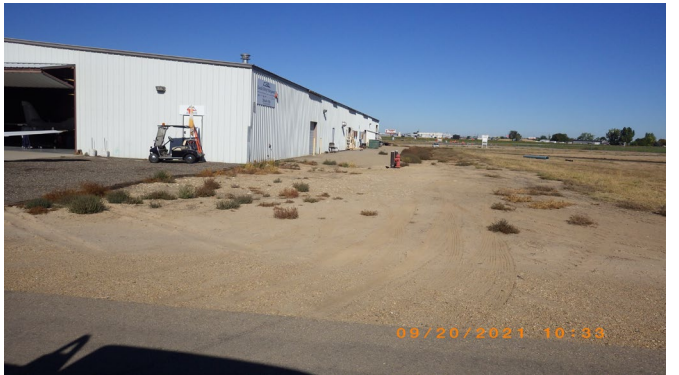
Cascade Aircraft Management (3901 Aviation Way)

Cascade Aircraft Management, LLC is covered under a No Exposure Certification (NOE) with IDEQ. Under the NOE, all industrial activities (maintenance, repairs, fueling, etc.) must be conducted exclusively indoors. At the time of the inspection, an aircraft was parked outside on the apron, with the engine cover open. Not only does the exposed engine pose a potential risk to polluting stormwater runoff, but is indicative of maintenance activities continuing to occur outdoors. In order to be in compliance with the NOE, **maintenance activities can only be conducted inside the hangar**. If this is not feasible for the Cascade, then a Notice of Intent (NOI) must be filed instead.

The dumpster does not have a lid, obtain a lid or comparably functional cover for the dumpster. Materials are being stored outside the hangar, along the northwest and northeast sides of the building, ensure that none of these materials are potential stormwater pollutants.

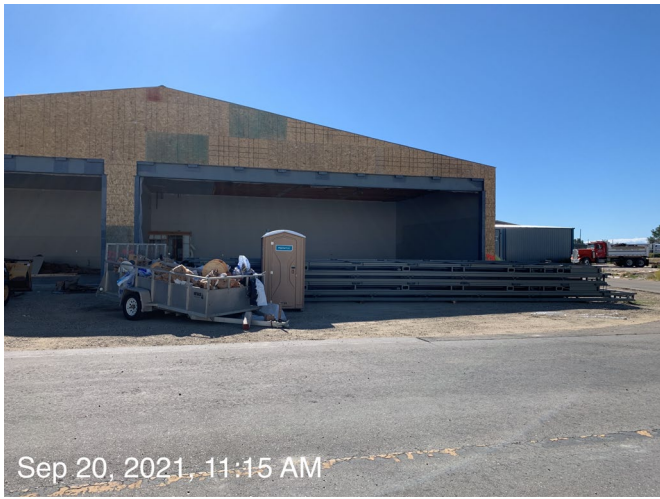
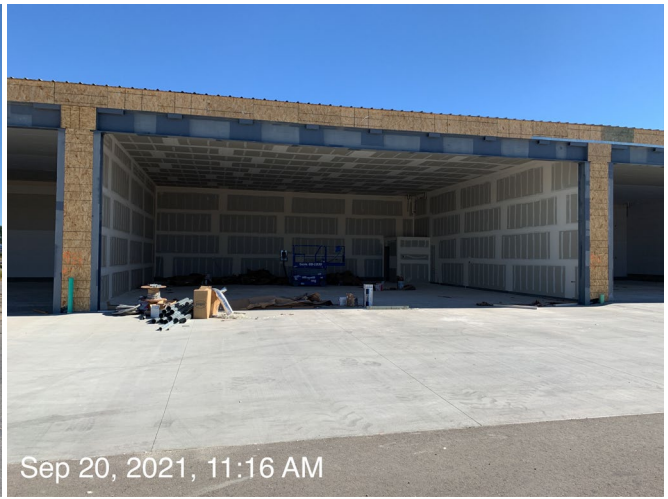
Construction Area (900 Block)

Construction materials are being stored outdoors, potential to contaminate stormwater runoff. These materials must be moved into the hangars (or otherwise covered or provided secondary containment) at the end of each work day.

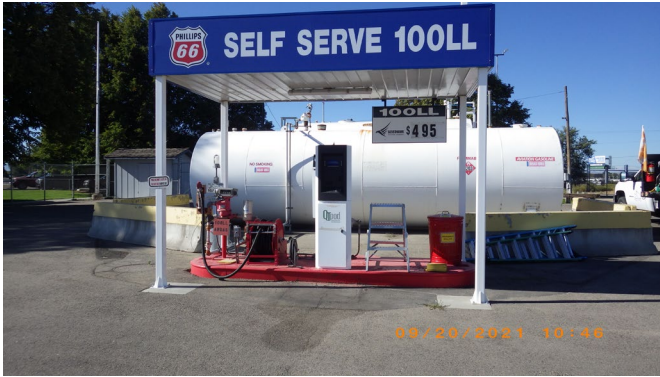
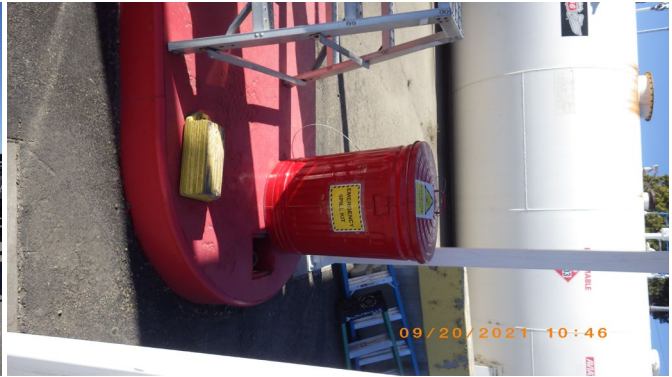
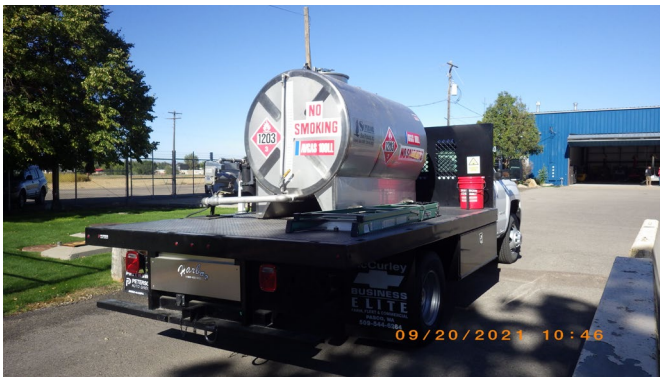
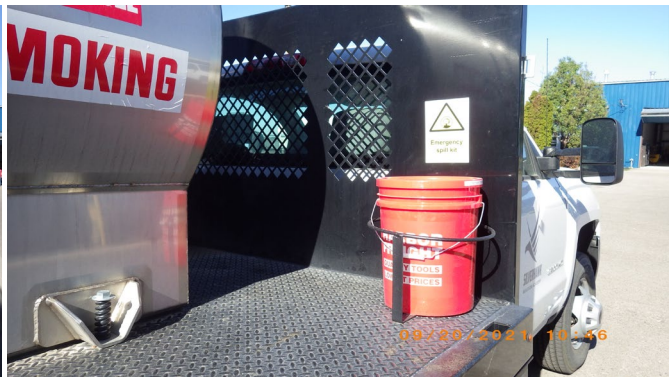
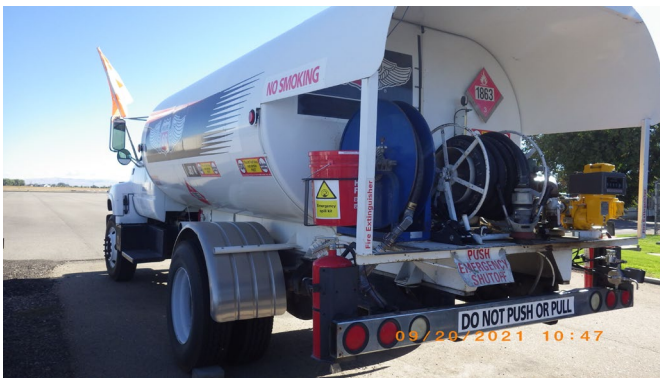
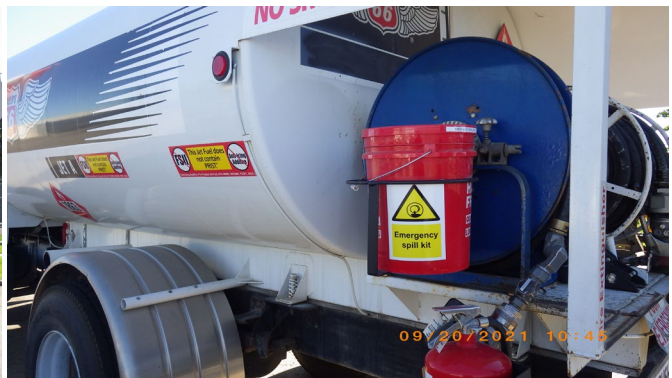
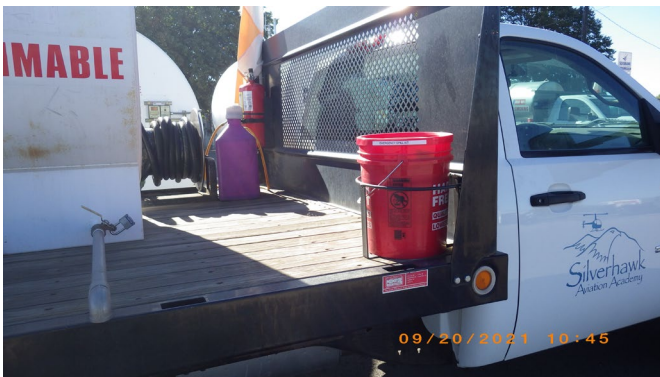
Silverhawk Site Refueling Station

Stationary fuel station has a spill kit that is well marked and easily accessible, as well as a cover for the fuel pump. All mobile tankers have individual spill kits onboard, clearly marked and easily accessible. This is a great job all around!

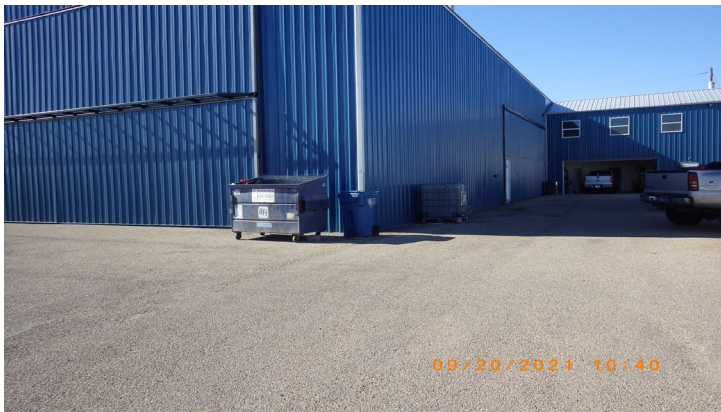
Silverhawk Aviation Hangar (4505 Aviation Way)

The majority of the chemical drums and containers that were being stored outdoors have been removed, good job! One remaining container yet to be removed/provided secondary containment. Onsite dumpster lid is missing, should be replaced. I spoke with Silverhawk's stormwater responsible person during the inspection, he informed me that a lid had recently been installed on the dumpster but it broke off, a new one is scheduled to be installed. The final container is also scheduled to be moved into the hangar.

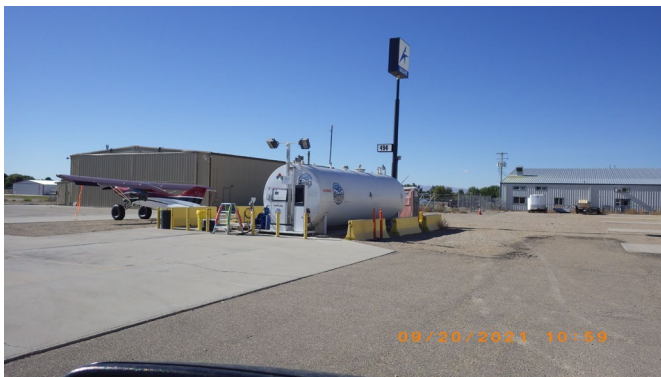
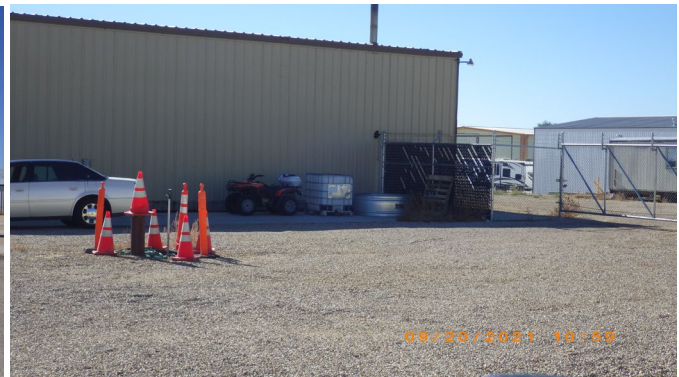
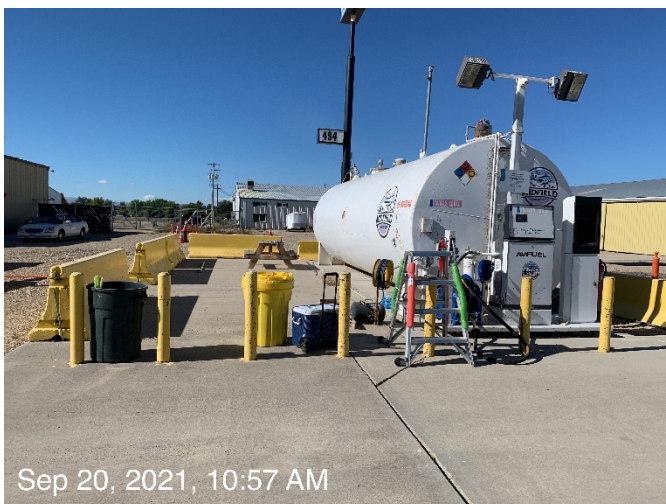
Midfield Aviation Stationary Self-Serve Refueling Station

Spill kit is onsite and easy to find, great job! **Please install a cover for the fuel pump.**

There is a white container next along the northwest wall of the building, it appears to be empty. If the container is not empty or contains anything other than potable water, please provide secondary containment (e.g. place the container in the metal trough it is sitting next to).

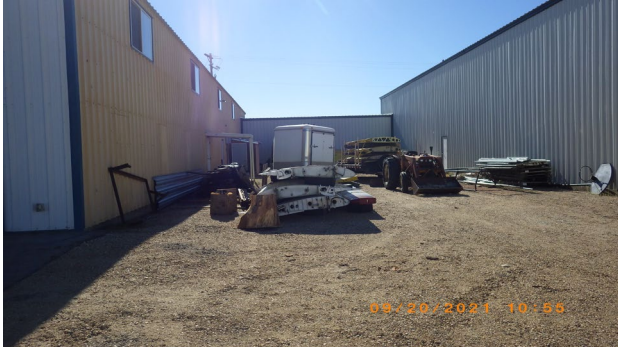
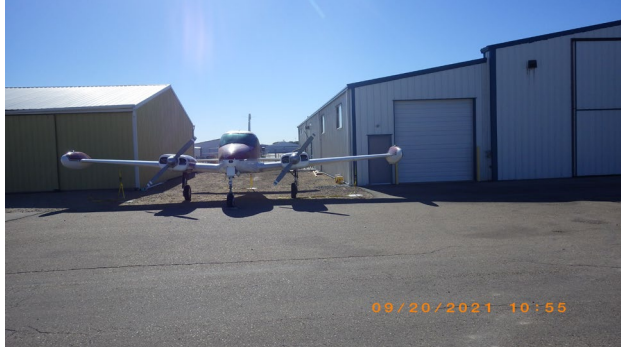
Flight Doctor West (515 Taildragger Place)

Two containers were observed outside the hangar, near the north corner of the building. These containers should be stored inside. Appears to have organized/removed some materials from the outdoor storage area. Continue to ensure that none of the materials in the outdoor storage area pose a risk to polluting stormwater runoff.

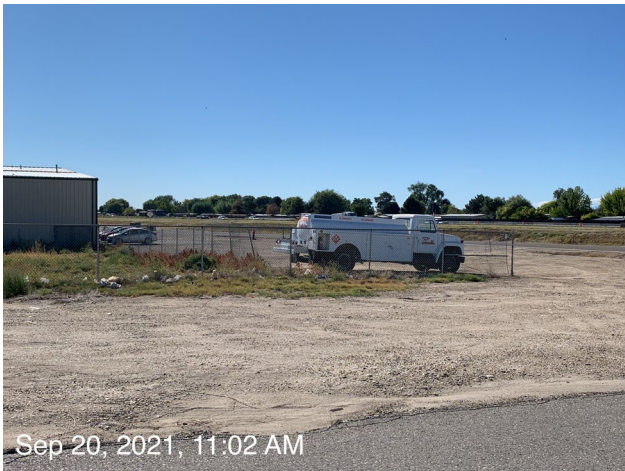
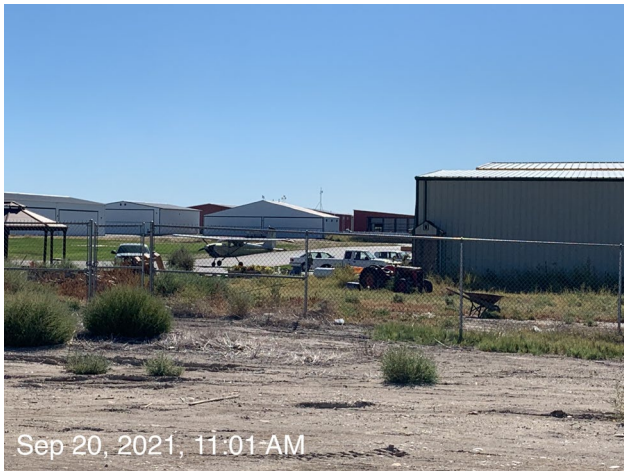
Skydown Skydiving Hangar and Fuel Tanker

It has been determined through conversations with the owners of Skydown Skydiving that the mobile fueling tanker is not (nor has it historically been) operable and that the intention is to sell the tanker in the near future. Please get rid of the tanker as soon as possible. Moderate amount of materials are being stored outside the hangar. Should consider garbage service (i.e. a covered dumpster) for the site.

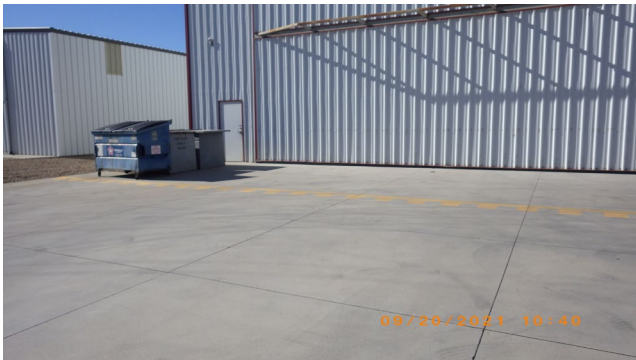
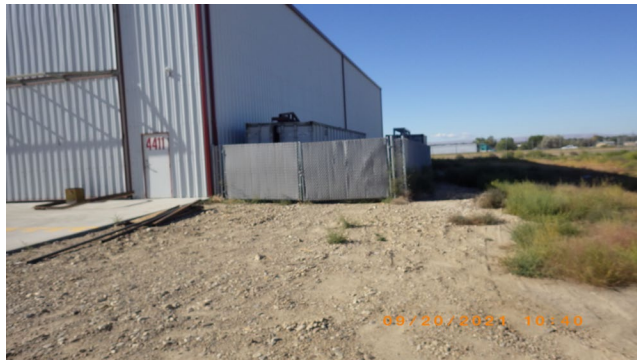
Vintage Airframes, LLC (4411 Aviation Way)

Dumpsters are covered and aircraft engine that had been stored outside the hangar, has been removed, good job! Rusted metal pieces on the apron should be placed inside, under cover, or in a disposal receptacle (as appropriate/applicable).

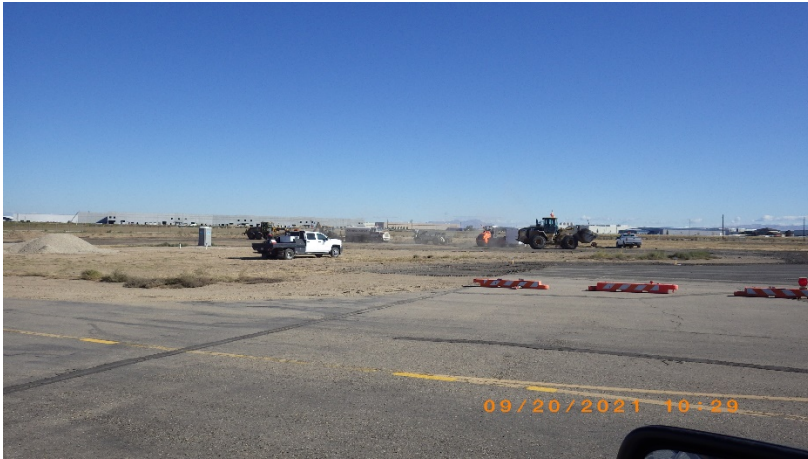
Taxiway Expansion Construction

Construction activity was generating some dust at the time of the inspection, use a water truck or other dust-control method as needed to minimize blowing dust.
