## Stormwater Industrial Routine Facility Inspection Report

General Information			
Facility Name	Caldwell Industrial Airport		
NPDES Tracking No.	IDR 050007		
Date of Inspection	December 1, 2021	Start/End Time	2:30 PM / 4:00 PM
Inspector's Name(s)	Emily Johnson		
Inspector's Title(s)	Environmental Engineer (City of Caldwell Stormwater Program)		
Inspector's Contact Information	ejohnson@cityofcaldwell.org		
Inspector's Qualifications	SWPPP Primary Contact		
Weather Information			
<b>Weather at time of this inspection?</b>			
<input checked="" type="checkbox"/> Clear <input type="checkbox"/> Cloudy <input type="checkbox"/> Rain <input type="checkbox"/> Sleet <input type="checkbox"/> Fog <input type="checkbox"/> Snow <input type="checkbox"/> High Winds <input type="checkbox"/> Other:                                      Temperature: 51°F			
<b>Have any previously unidentified discharges of pollutants occurred since the last inspection?</b> <input type="checkbox"/> Yes <input checked="" type="checkbox"/> No If yes, describe:

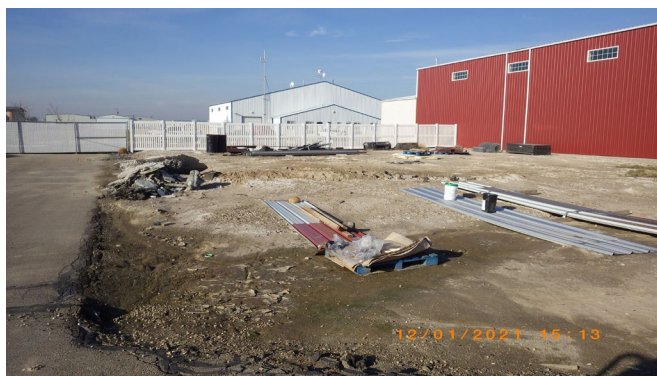
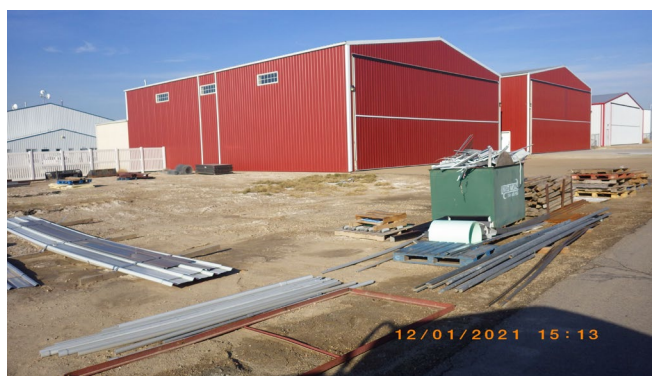
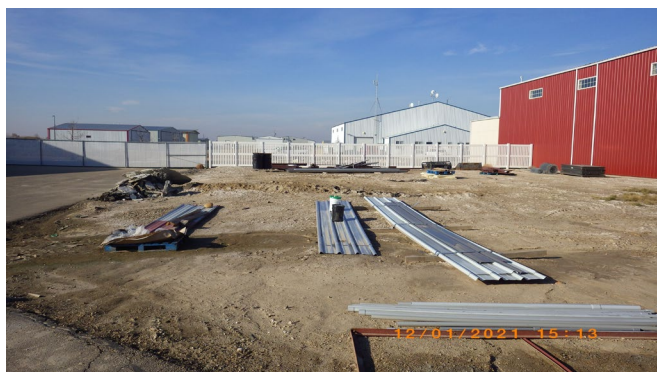
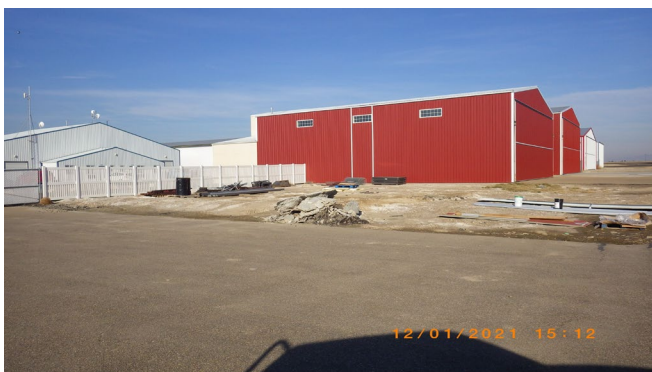
#### Construction Area (between 504 and 516 Dauntless Place)

Unidentified drums and containers are being stored outside without any secondary containment; these materials **must** be stored inside, under cover, or with secondary containment to prevent contamination of stormwater runoff. The dumpster must have a lid or functional cover, and must be covered. No materials that could pollute stormwater runoff can be stored outside. Concrete was previously washed out directly onto the ground and into a damaged concrete washout that was not effectively containing the material; reminder that concrete can **only** be washed out into a functioning designated concrete washout area. To remediate non-compliance status:

- Store drums and containers inside, under cover, or with sufficient secondary containment
- Obtain and use a lid (or other functional cover) for the dumpster
- Store any potential pollutants inside, under cover, or with secondary containment
- Install and maintain a concrete washout if any additional concrete pouring will occur

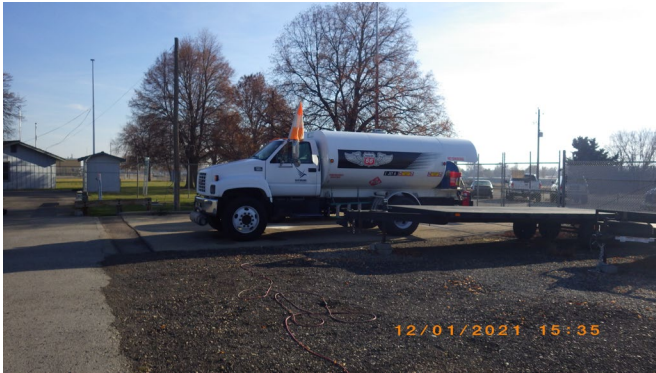
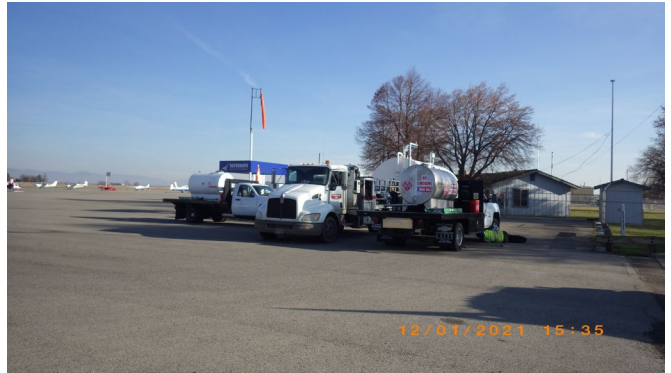
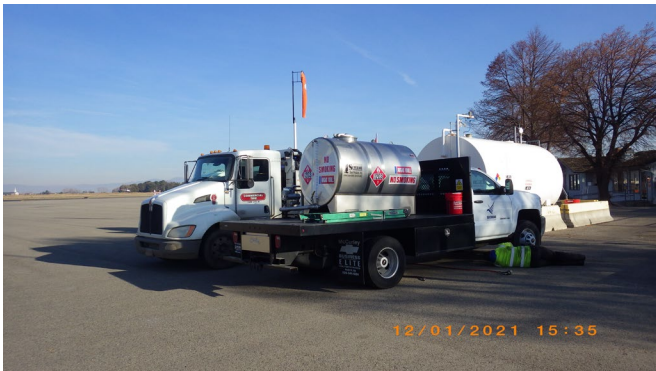
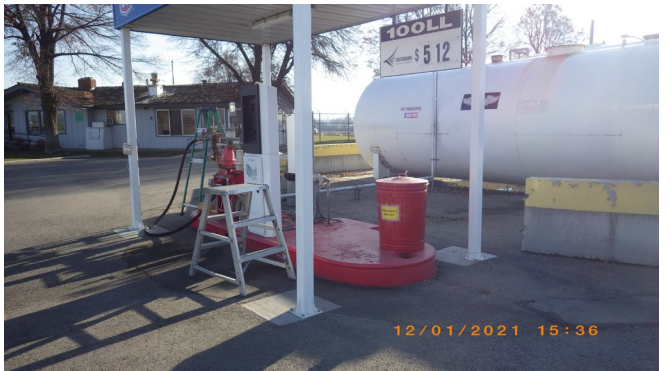
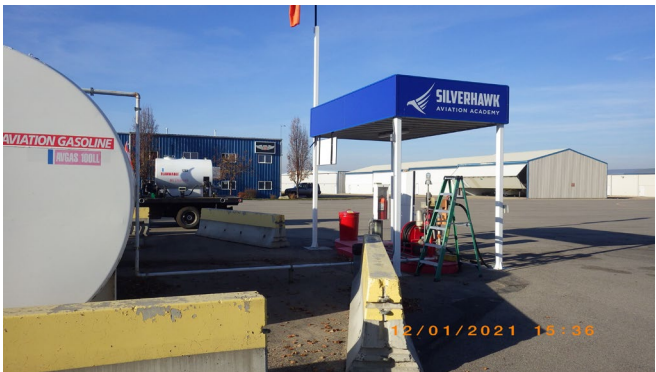
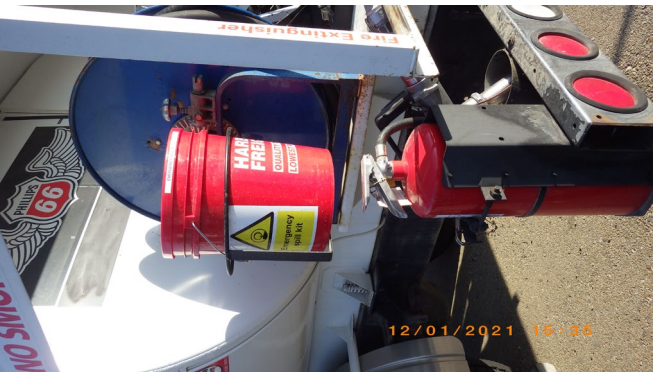
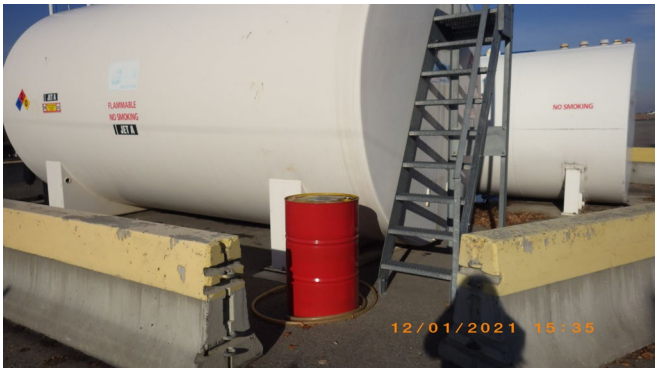
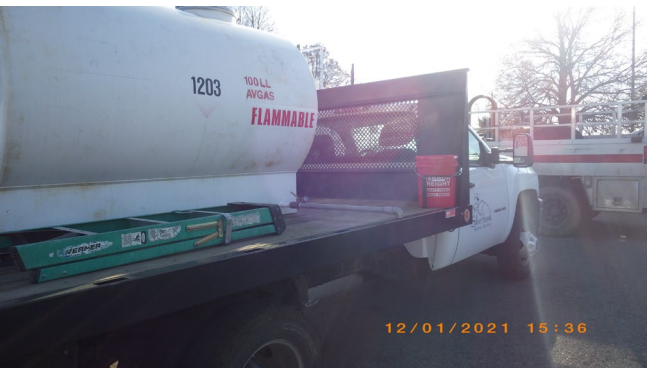
**Silverhawk Site Refueling Station**

Stationary fuel station has a spill kit that is well marked and easily accessible, as well as a cover for the fuel pump. All mobile tankers have individual spill kits onboard, clearly marked and easily accessible. This is a great job all around!

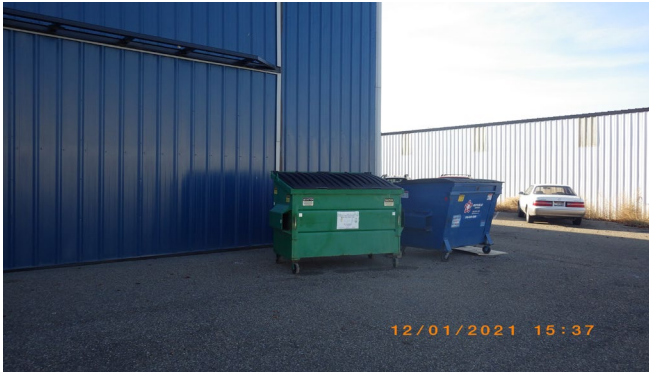
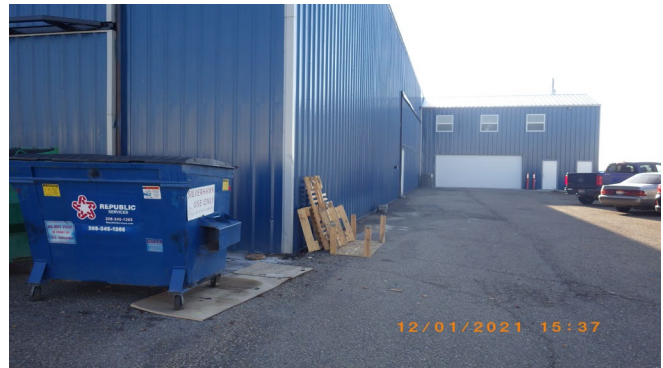
**Silverhawk Aviation Hangar (4505 Aviation Way)**

All of the chemical drums and containers that were being stored outdoors have been removed and the dumpster has a lid, overall Silverhawk is doing a great job!

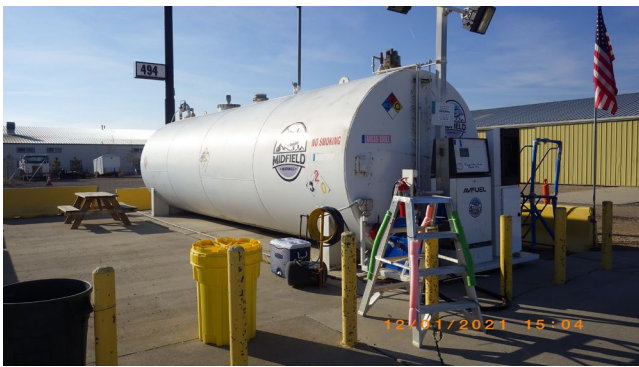
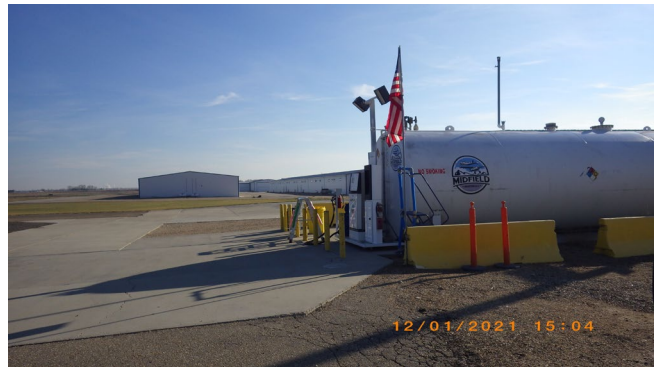
**Midfield Aviation Stationary Self-Serve Refueling Station**

Spill kit is onsite and easy to find, great job! Please install a cover for the fuel pump.

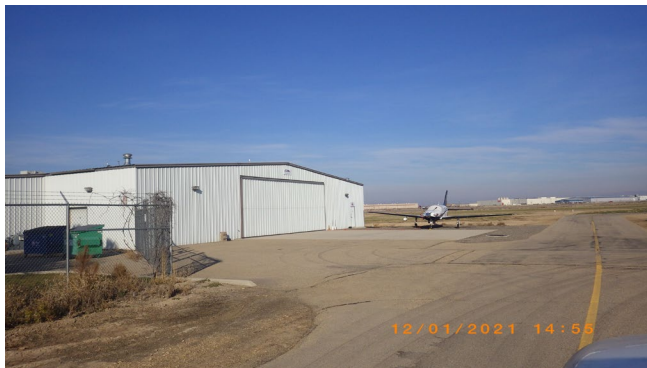
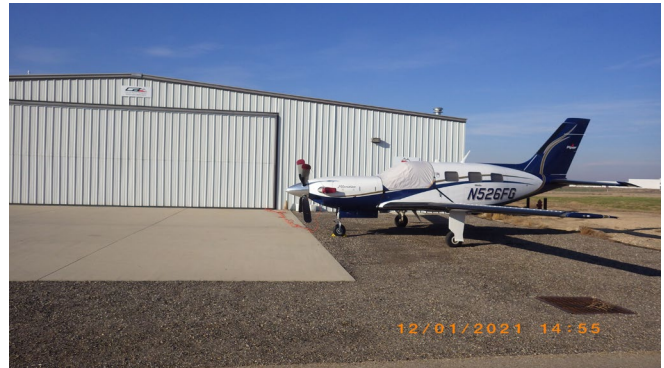
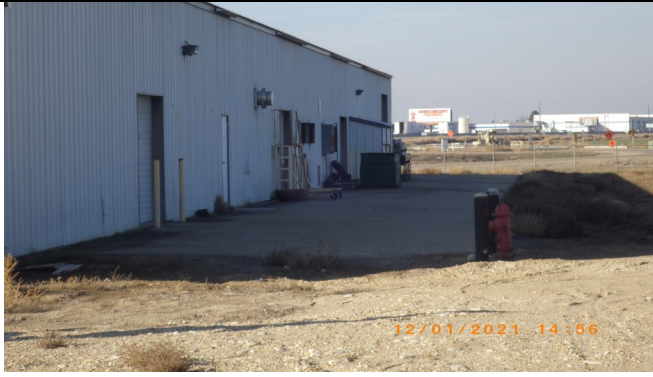
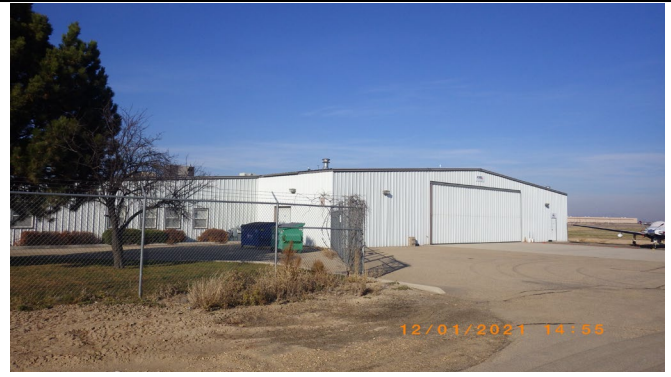
**Cascade Aircraft Management (3901 Aviation Way)**

A lid has been installed on the dumpster since the Q3 inspection. During the Q4 inspection, there were no signs of maintenance activities being conducted outside of the hangar, good job!

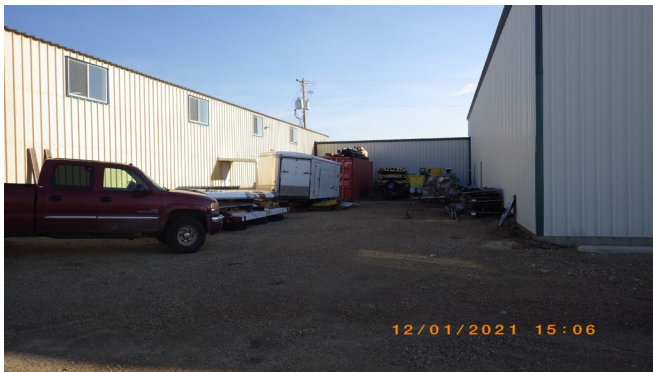
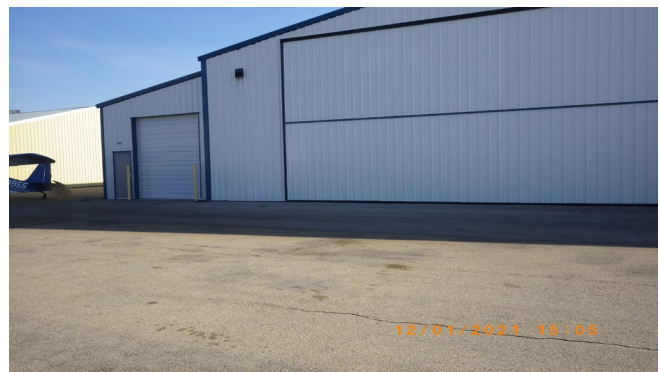
**Flight Doctor West (515 Taildragger Place)**

Appears to have organized/removed some materials from the outdoor storage area. Continue to ensure that none of the materials in the outdoor storage area pose a risk to polluting stormwater runoff.

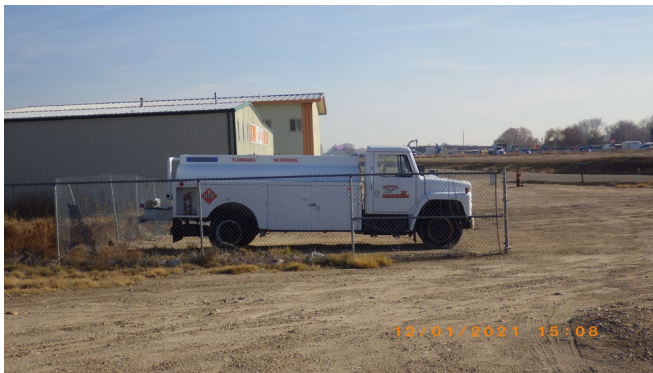
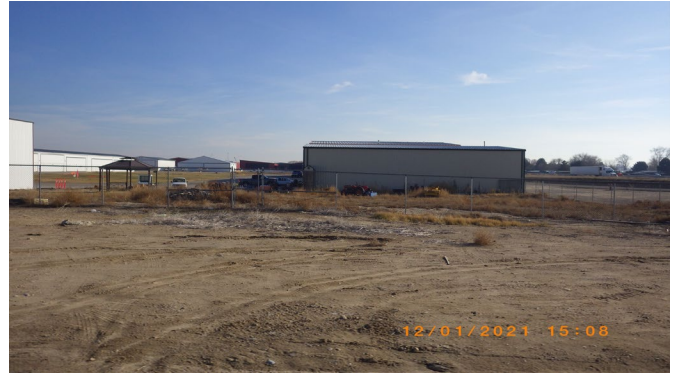
**Skydown Skydiving Hangar and Fuel Tanker**

It has been determined through conversations with the owners of Skydown Skydiving that the mobile fueling tanker is not (nor has it historically been) operable and that the intention is to sell the tanker in the near future. Please get rid of the tanker as soon as possible. Moderate amount of materials are being stored outside the hangar. Should consider garbage service (i.e. a covered dumpster) for the site.

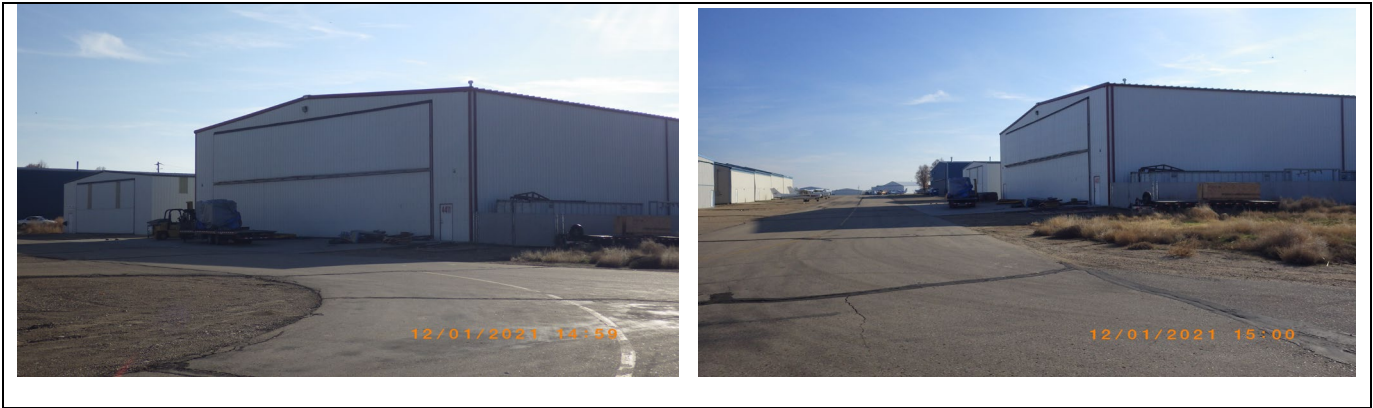
**Vintage Airframes, LLC (4411 Aviation Way)**

Increased number of materials being stored outside on the hangar apron. Ensure that these materials are being properly protected from polluting stormwater runoff and that facility is compliant with the SWPPP.
